# Wetlands Rehabilitation / Trailhead Design

South Beach, Washoe Lake, NV

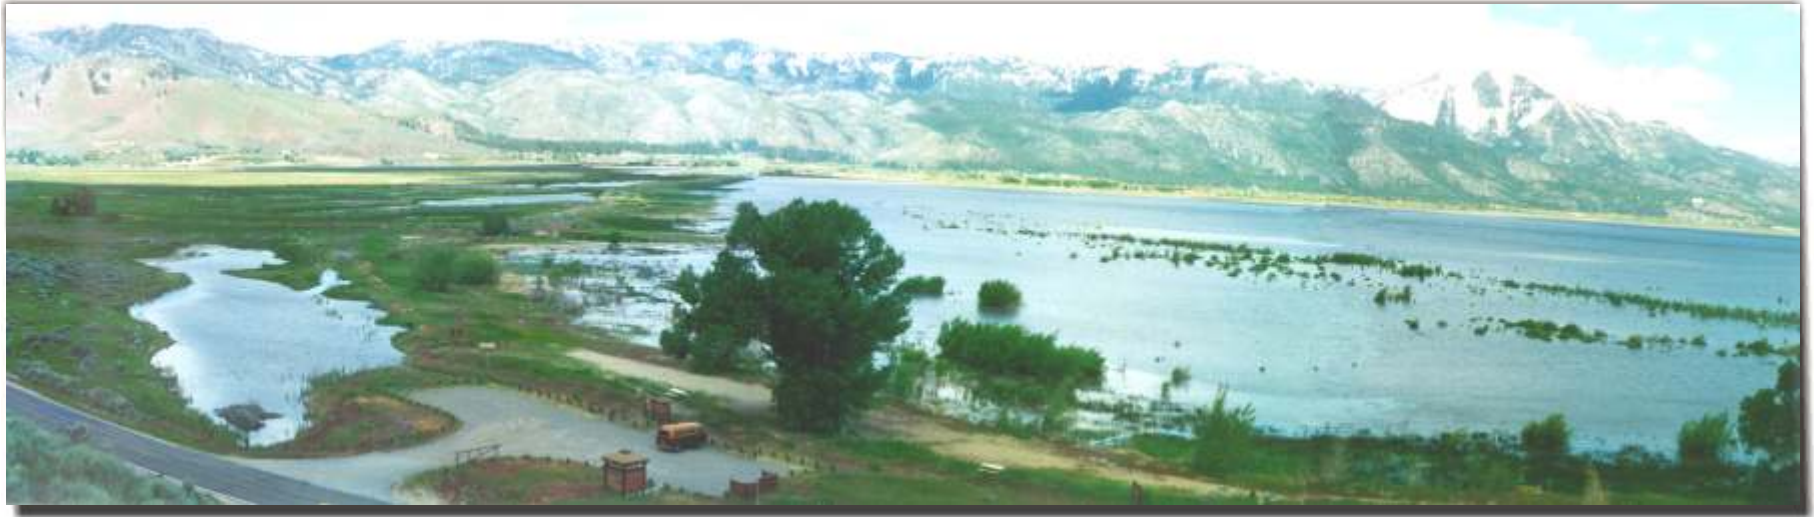
Panorama of the South Beach wetland rehabilitation and Trailhead

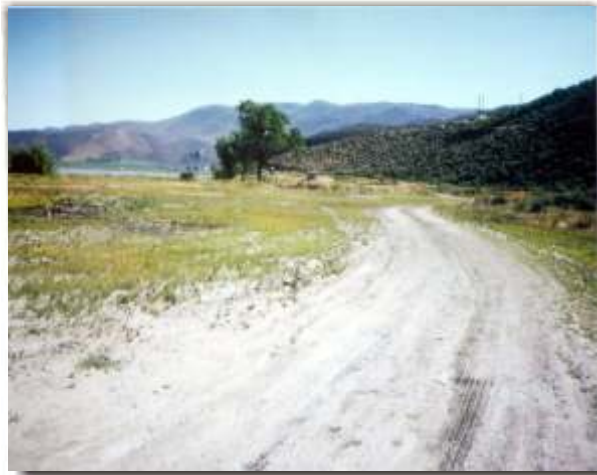
Typical view of vehicle impacted seasonal wetland zone. Working with an inter-disciplinary team the landscape architect developed the design for the site .

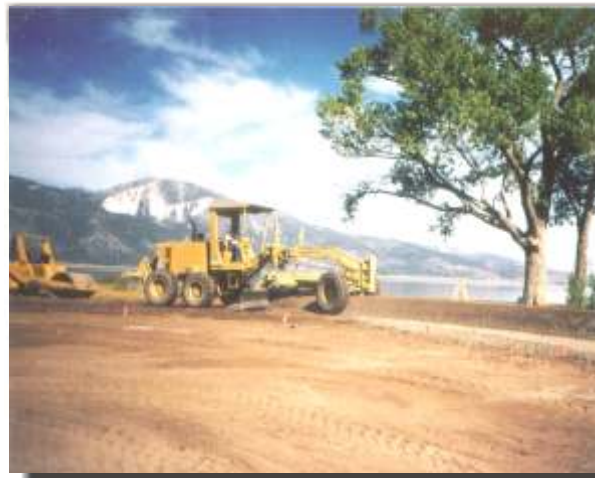
Large equipment implemented the grading plan, which included specific wetland water depths and spot elevations that placed user facilities above historical flood impact.

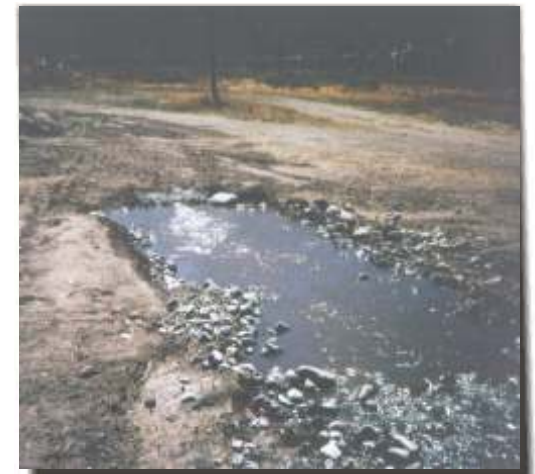
A water piping system was designed to sustain the wetland zone through summer. Here the wetland begins initial flooding.

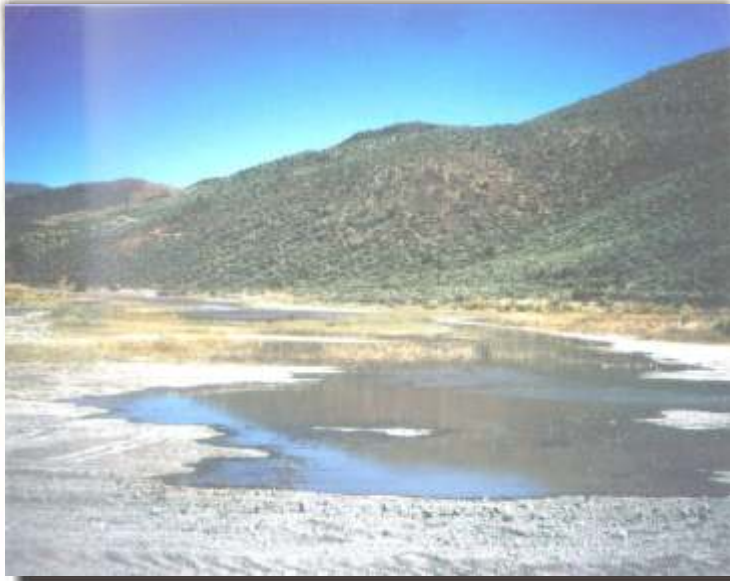
The wetland flooding proceeds, re-wetting the soil for the eventual rejuvenation of plant, wildlife, and scenic resource.

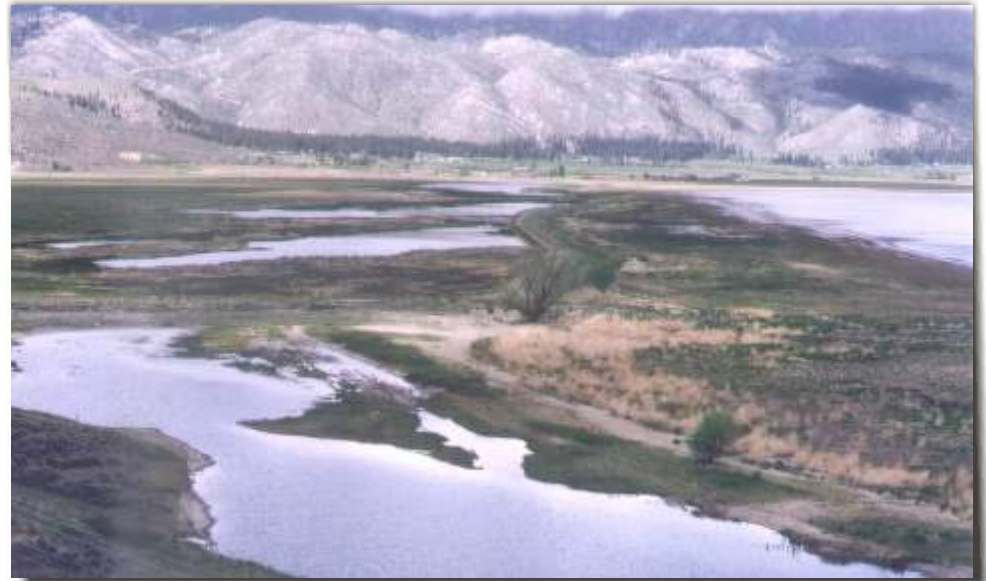
As the wetland zone reaches flood stage the surrounding land is prepared and re-seeded with desirable wetland zone species.

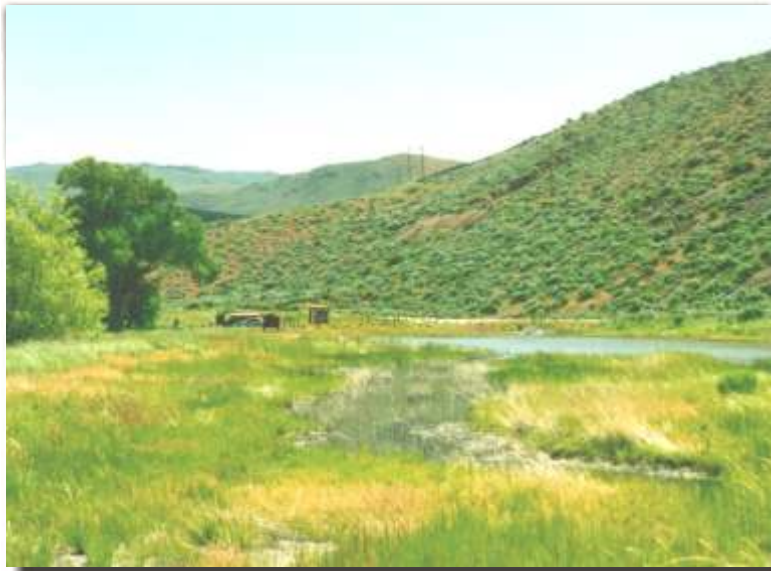
After several seasons a vigorous wetland zone is apparent. This photo can be compared to the one directly above it.

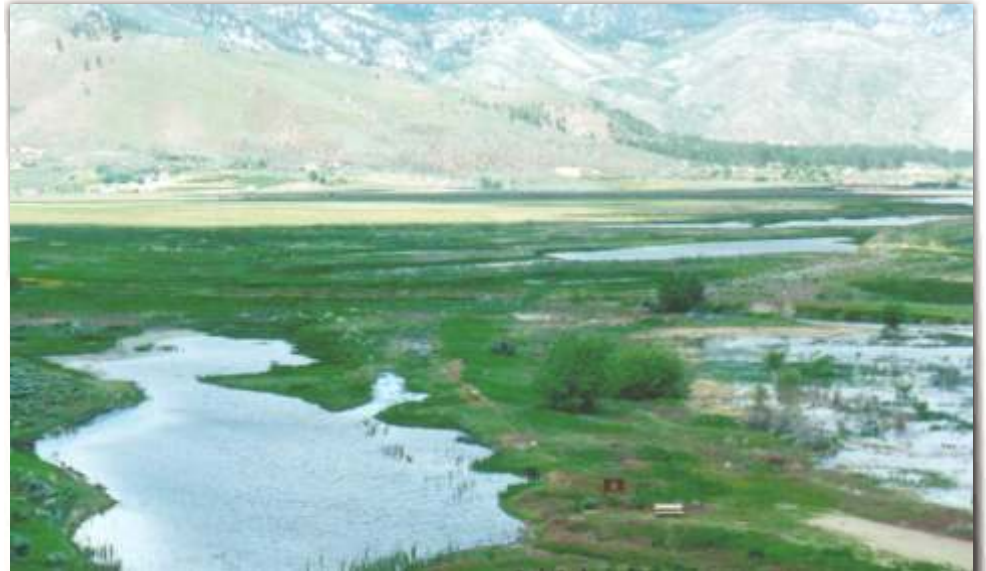
In full Spring growth the wetlands are now viable habitat for birds and mammals. This photo can also be compared to the one above it.

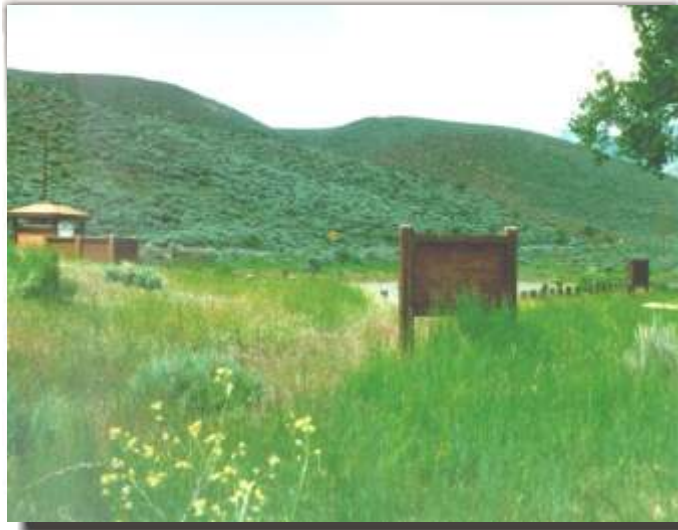
With the addition of comfort station, limited parking, and trails, South Beach is ready for visitors

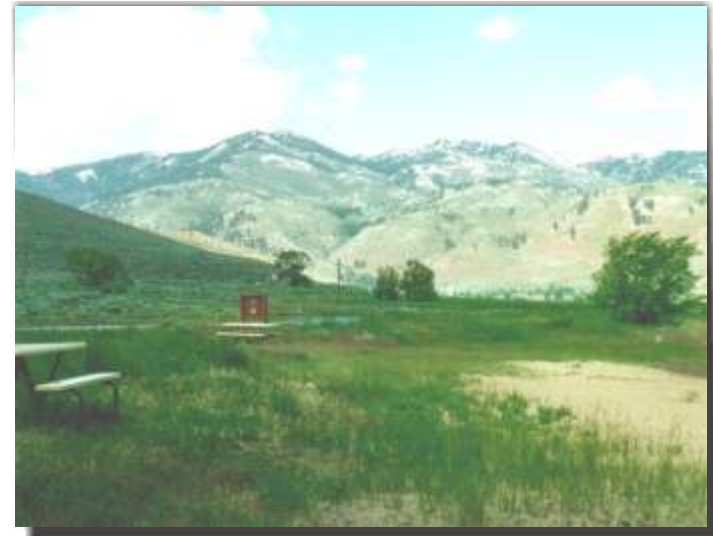
The area is a successful recreation amenity with interpretive signage and trail system. It has become an attractive element in the park system.

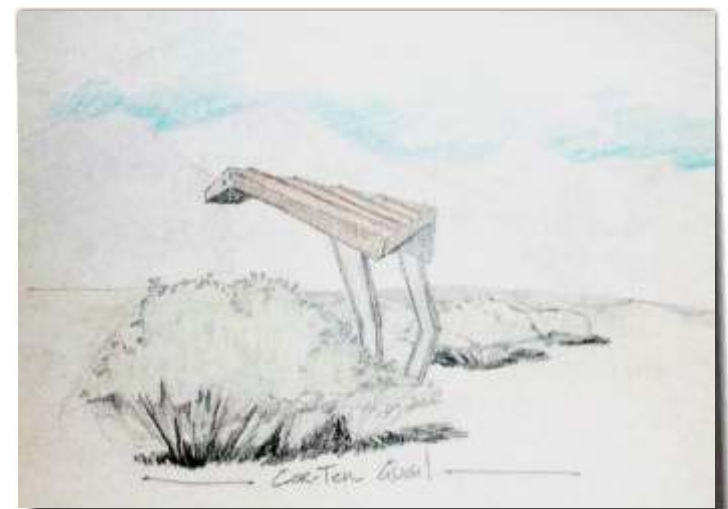
Form as Function. This artistic shade structure represents the form of a native upland bird .

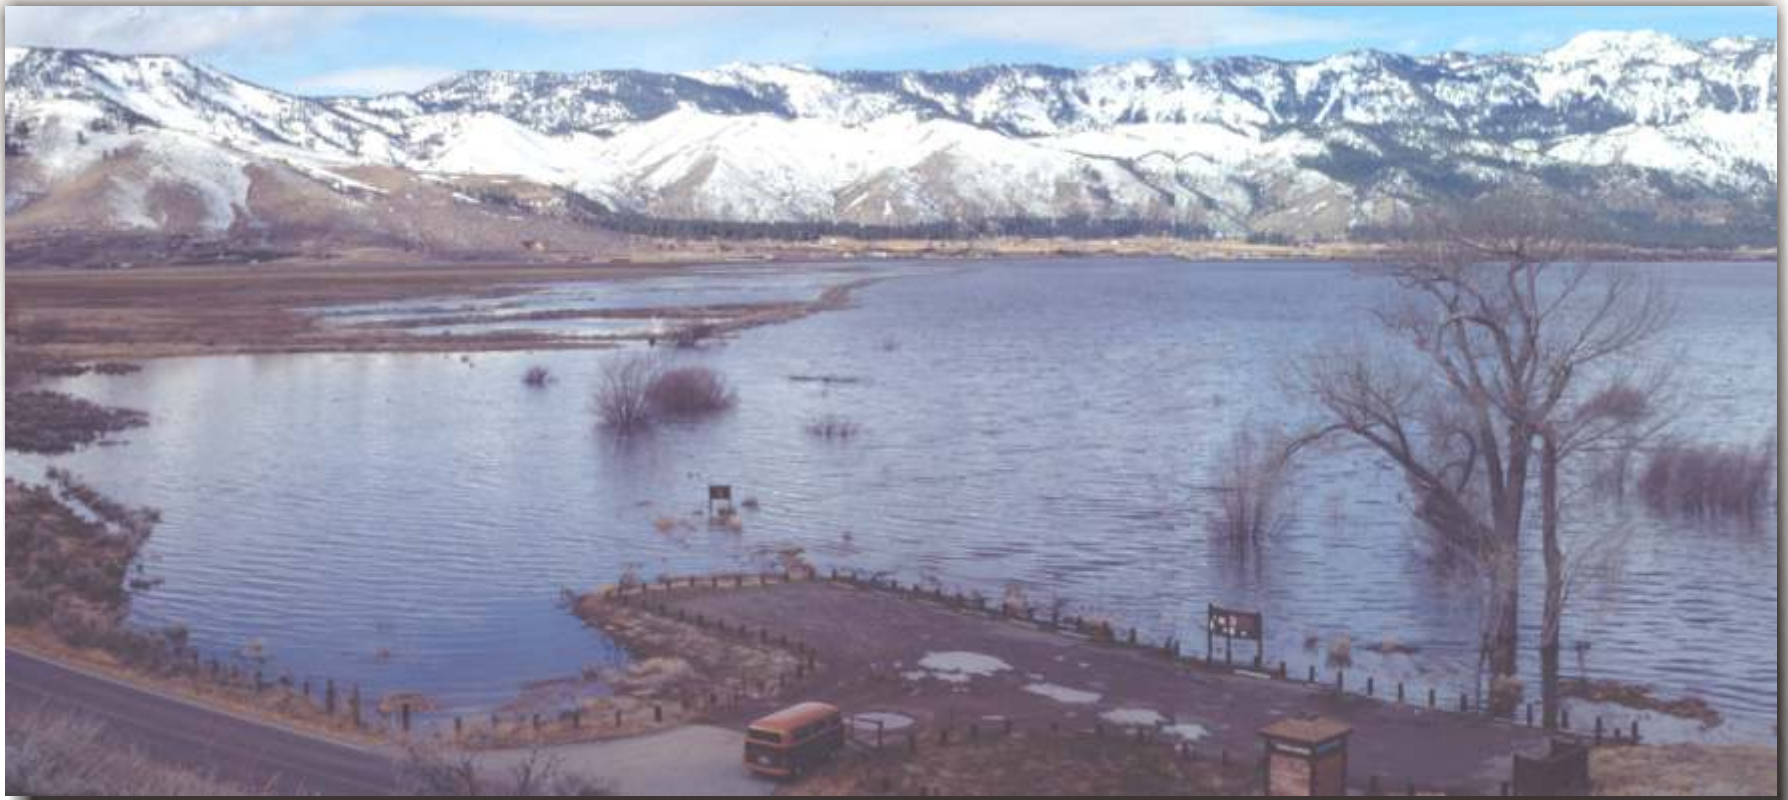
Wetlands after winter flooding. Note user amenities are above flood water (Good design saves money).
